How to get a fine!

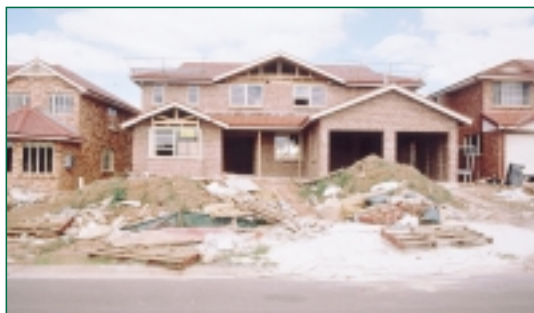
Fines issued to this site were for general untidiness of the site, the positioning of the stockpile, the need for maintenance of the sediment fence and the lack of an all weather access point.

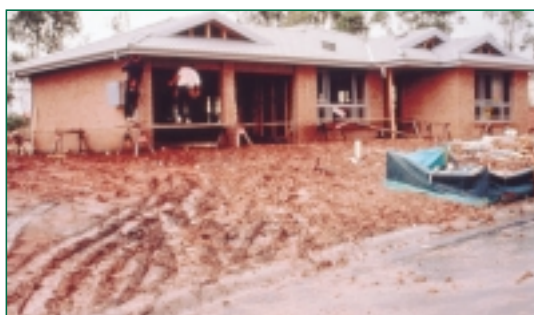
Rain, hail or shine, sediment controls should be in place at all times, prior to, and during building works. This site is clearly causing pollution which flows to creeks via the drains around the site.

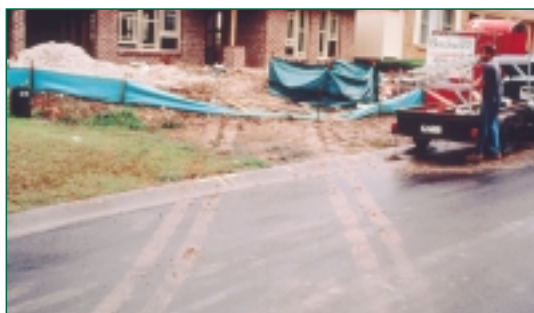
This is a typical situation where a 'entry-exit access' point has not been provided and a tradesman has driven straight over the top of a sediment fence. A stabilised track allows vehicles to enter and exit the site safely during all weather conditions without destroying sediment fences, valuable grass or carrying large amounts of mud and dirt on to the road.

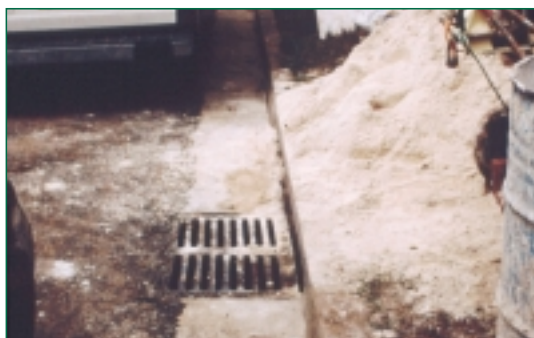
Soil in street gutters are a clear sign of inadequate erosion and sediment controls. A sediment fence and grass filter strip could assist in this situation, stopping the dirt before it enters the stormwater system.
